# 3809 REPORT OF INSPECTION

Date: August 16, 2006 Time: about 11:20 am Location: T.5S. R.24E. Sec 6 S2 of Lot 8

Serial no. of notice: UTU 66357 (Bluebell Oil Co project area) Is the operation active? No (expired)

Serial no. of notice: UTU 66366 (Dale Stevens expired project area) Is the operation active? No

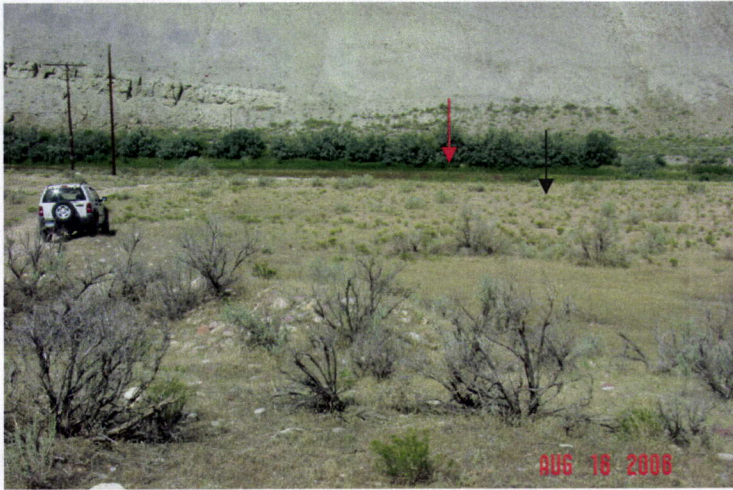
< figure 1, view to west (from near SE corner of project area); southern part of project area is against road at left; western part of project area is over edge (pointed to by red arrow; to near side of the Green River – far bank of which is the green band of vegetation in this image), but which is not into the flood plain; southeastern part of project area (in foreground) was not subjected to the last placer activity on location (referred to a naturally revegetating [black arrow points at it] area below; has not been seeded by the operator, has some desirable native volunteer vegetation emerging, but at a lesser density as nearby undisturbed land). Compare with frame 1 of 2005 inspection

Is the operation in compliance with the notice on file and/or the stipulations of the approved plan? (if No describe deficiencies): No. Seeding has not been conducted.

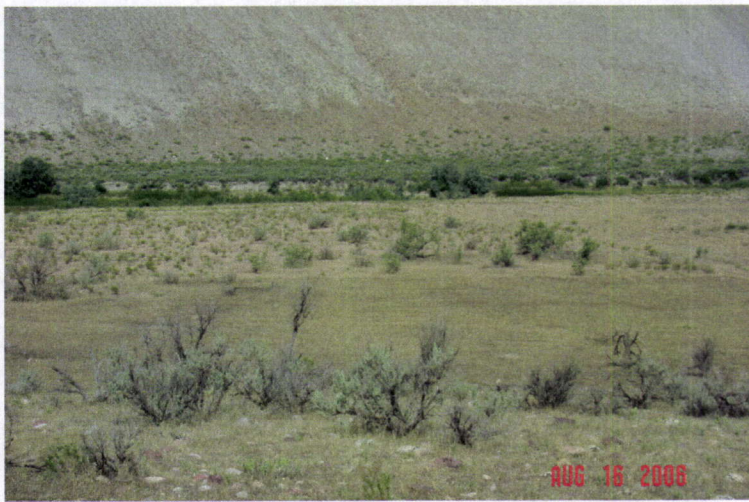
< figure 2, view to west-northwest (pan to right of image 1), area that was reshaped in 9/2004 is from far right-center to middle part of image (naturally revegetating area is to left, of greener patch at far-right – this patch is composed mostly of cheatgrass which is emerging)

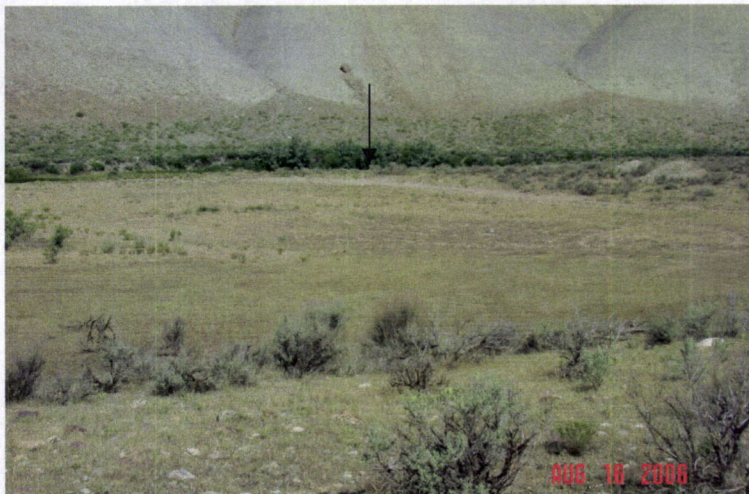
< figure 3, view to northwest (pan to right of image 2), northeast corner of project area is near the center of the image (pointed to by black arrow). Reshaped area [that has yet to be seeded and has a cover of cheat grass is in the middle-ground.

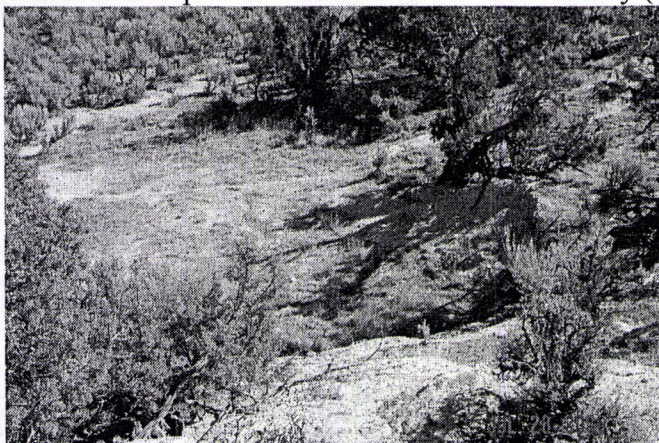
Description of operations (including access, reclamation, etc.): The operator had filled the shallow excavation at the base of a rock ledge (see image 1 below, compare with image 1 of prior inspection). The scattered pile of wood and a few tires nearby (image 2 below) have yet to be removed.

image 1 – filled opening

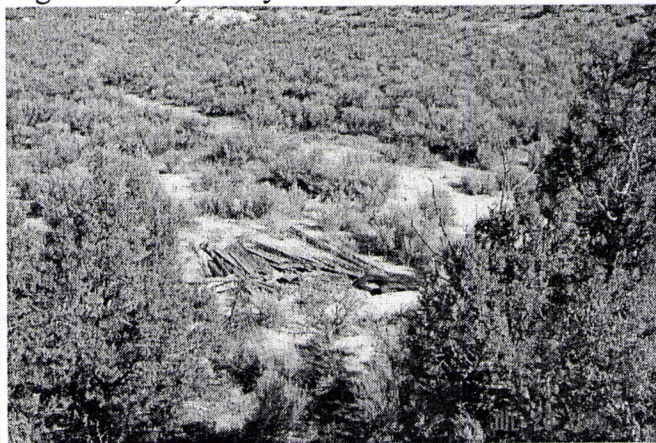
image 2 – pile of material nearby

Is the operation in compliance with the notice on file and/or the stipulations of the approved plan? (if No describe deficiencies): Generally yes. The excavation has been filled. The case can be closed when the pile of material nearby is removed (as ordered in our 6/4/2003 certified “notice expired” decision). A letter indicating that material must be removed will be sent.
